**Flood Control Project Maintenance
Levee Inspections**

Maintenance Issue Types Only, Levee Inspection Report By Mile - Spring 2019

Sutter Maintenance Yard Tisdale Bypass

Waterway	Bank	Unit Miles	Inspection Start/End	Inspector
Unit No. 01 Tisdale Bypass	Left	4.51	05/09/2019 05/09/2019	Makar Sokol

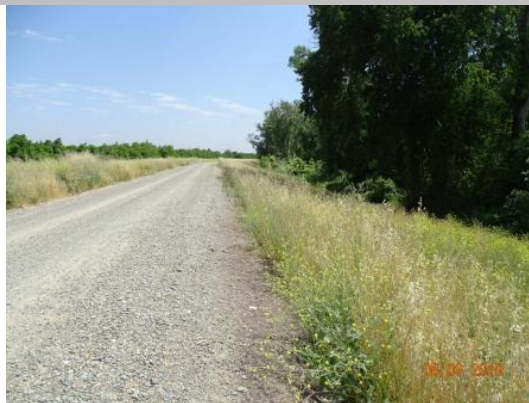
Photo 1 of 1 : SP_2019_ST0009_286_14_20190510_00019.jpg

LM Start	0.02	Rating **	U	Issue No.	14
LM End	4.50	Issue Type +	Ma	Location *	WS
Category	Earthen Levee			GPS Latitude/Longitude	
				Start	End
Item	Vegetation			39.027150 °	39.032827 °
				-121.821447 °	-121.743098 °
DWR ID	DWR_ST0009_01_s_2017_14				
Comment Code					
V1 : Control annual grass and weeds on the levee slopes and easements.					
Inspector Comment

View of the vegetation on the waterside slope. Spring 2019.

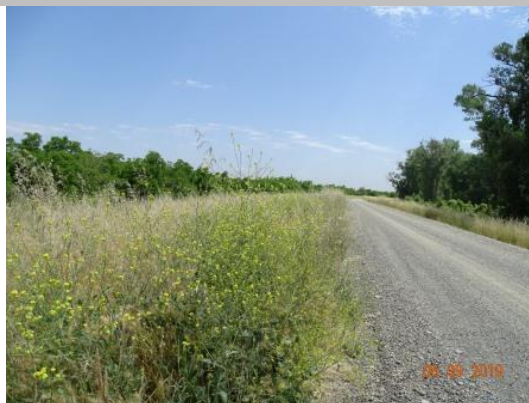
Photo 1 of 1 : SP_2019_ST0009_286_13_20190510_00020.jpg

LM Start	0.02	Rating **	U	Issue No.	13
LM End	4.50	Issue Type +	Ma	Location *	LS
Category	Earthen Levee			GPS Latitude/Longitude	
				Start	End
Item	Vegetation			39.027150 °	39.032895 °
				-121.821447 °	-121.743027 °
DWR ID	DWR_ST0009_01_s_2017_13				
Comment Code					
V1 : Control annual grass and weeds on the levee slopes and easements.					
Inspector Comment

View of the vegetation on the landside slope. Spring 2019.

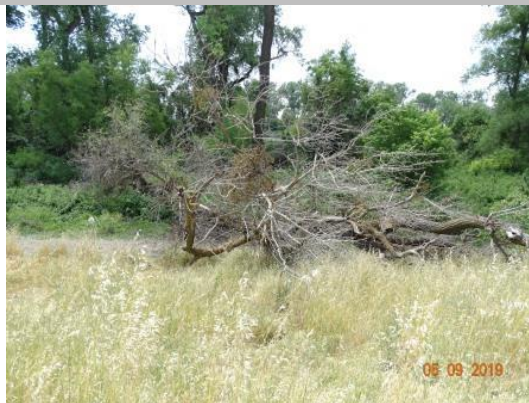
Photo 1 of 1 : SP_2019_ST0009_286_10_20190510_00021.jpg

LM Start	0.77	Rating **	U	Issue No.	10
LM End	0.77	Issue Type +	Ma	Location *	WS
Category	Earthen Levee			GPS Latitude/Longitude	
				Start	End
Item	Encroachments			39.028328 °	39.028328 °
				-121.807756 °	-121.807756 °
DWR ID	DWR_ST0009_01_s_2019_10				
Comment Code					
TR : Tree or limb					
Inspector Comment					
The large tree should be removed from the waterside slope.

View of a large tree on the waterside slope. Spring 2019.

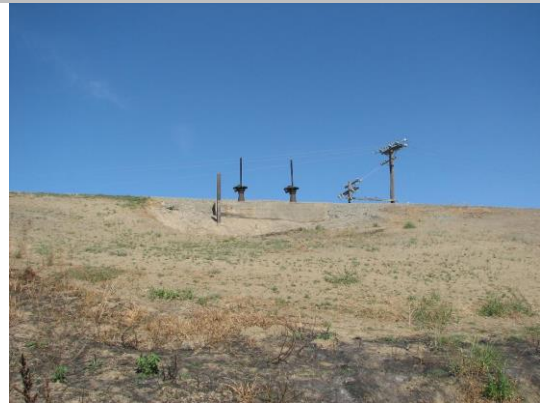
Photo 1 of 3 : UCIP_SP_2019_51484_64226.jpg

Comment Code					
Inspector Comment					
FS_ID:51484 DS_ID:16591 EP_NO: 10099 Repair Type: No Action Needed Crossing Status: Found UCIP Comments: 4/10/2017 Crossing appears to be in good condition. (DWR Sutter Yard- A Freitag)10/11/2016 Crossing appears to be in good conditon.(DWR Sutter Yard - a Freitag)4/18/2016 Crossing appears to be in good condition. No noticeable issues to report.5/7/2015 Crossing is in good condition. No noticeable issues to report.11/13/2014 Same as last inspection.5/12/2014 Same as last inspection.10/30/2013 Same as last inspection.5/20/2013 Same as last inspection. FIELD_STRUCT_DESC: 1 of 2: 4-foot by 7-foot reinforced concrete discharge tunnel through the levee, 38 feet below the crown. Slide gate in 4-foot by 15-foot concrete well on the waterside (WS) slope. Pump house located on the landside (LS) toe and wooden flap gates on the WS toe. (two 4-foot by 7-foot tunnel [HLM 2.13] authorized under Automatic Board Order (ABO) issued as Permit No. 10099, 1955 - Reclamation District No. 1660). [Additional Reference(s): DWR Levee Log, 1993. USACE Sacramento O&M Manual 133, August 1955 (Station 1044+60)]. FS Date: 4/12/2017 9:20:05 AM

Slide gates on WS shoulder.

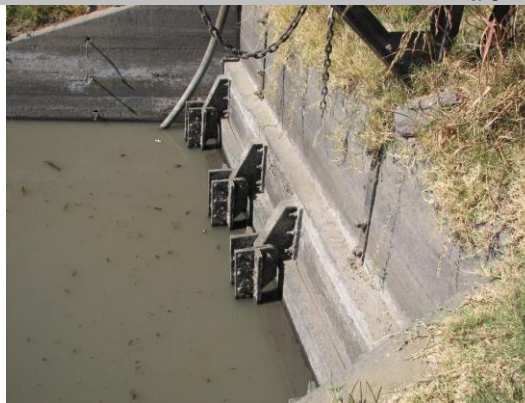
Photo 2 of 3 : UCIP_SP_2019_51484_64225.jpg

Wooden Flap gates on WS toe.

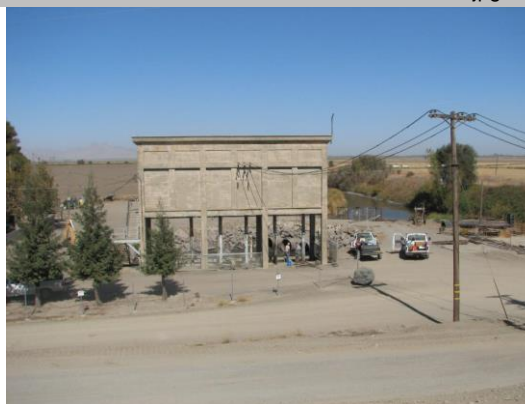
Photo 3 of 3 : UCIP_SP_2019_51484_64224.jpg

Pump house on LS toe.

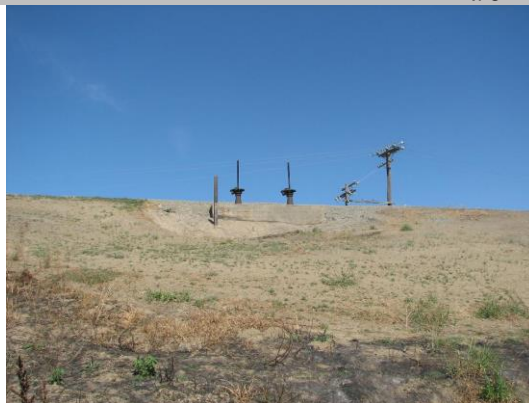
Photo 1 of 3 : UCIP_SP_2019_51485_64230.jpg

Comment Code					
Inspector Comment					
FS_ID:51485 DS_ID:16856 EP_NO: 10099 Repair Type: No Action Needed Crossing Status: Found UCIP Comments: 4/10/2017 Crossing appears to be in good condition. (DWR Sutter Yard- AFreitag)10/11/2016 Crossing appears to be in good condition.(DWR Sutter Yard - afreitag)4/18/2016 Crossing appears to be in good condition. No noticeable issues to report.5/7/2015 Crossing is in good condition. No noticeable issues to report.11/13/2014 Same as last inspection.5/12/2014 Same as last inspection.10/30/2013 Same as last inspection.5/20/2013 Same as last inspection. FIELD_STRUCT_DESC: 2 of 2: 4-foot by 7-foot concrete discharge tunnel through the levee, 38 feet below the crown. Slide gate in 4-foot by 15-foot concrete well on the waterside (WS) slope. Pump house located on the landside (LS) toe and wooden flap gates on the WS toe. (two 4-foot by 7-foot tunnel [HLM 2.13] authorized under Automatic Board Order (ABO) issued as Permit No. 10099, 1955 - Reclamation District No. 1660). [Additional Reference(s): DWR Levee Log, 1993. USACE Sacramento O&M Manual 133, August 1955 (Station 1044+60)]. FS Date: 4/12/2017 9:20:37 AM

Slide gates on WS shoulder.

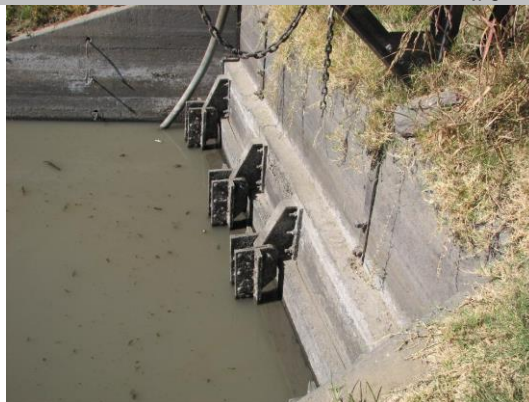
Photo 2 of 3 : UCIP_SP_2019_51485_64229.jpg

Wooden flap gates on WS toe.

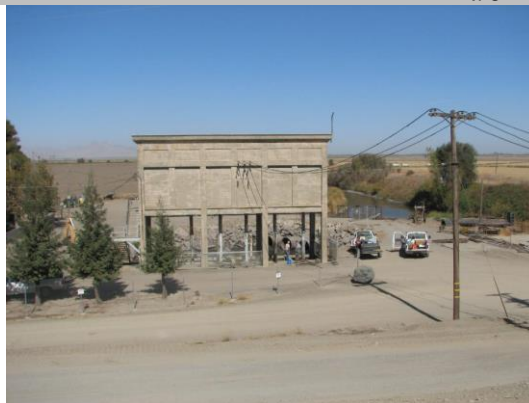
Photo 3 of 3 : UCIP_SP_2019_51485_64228.jpg

Comment Code						
Inspector Comment						
FS_ID:51485 DS_ID:16856 EP_NO: 10099 Repair Type: No Action Needed Crossing Status: Found UCIP Comments: 4/10/2017 Crossing appears to be in good condition. (DWR Sutter Yard- AFreitag)10/11/2016 Crossing appears to be in good condition.(DWR Sutter Yard - afreitag)4/18/2016 Crossing appears to be in good condition. No noticeable issues to report.5/7/2015 Crossing is in good condition. No noticeable issues to report.11/13/2014 Same as last inspection.5/12/2014 Same as last inspection.10/30/2013 Same as last inspection.5/20/2013 Same as last inspection. FIELD_STRUCT_DESC: 2 of 2: 4-foot by 7-foot concrete discharge tunnel through the levee, 38 feet below the crown. Slide gate in 4-foot by 15-foot concrete well on the waterside (WS) slope. Pump house located on the landside (LS) toe and wooden flap gates on the WS toe. (two 4-foot by 7-foot tunnel [HLM 2.13] authorized under Automatic Board Order (ABO) issued as Permit No. 10099, 1955 - Reclamation District No. 1660). [Additional Reference(s): DWR Levee Log, 1993. USACE Sacramento O&M Manual 133, August 1955 (Station 1044+60)]. FS Date: 4/12/2017 9:20:37 AM

Pump house on LS toe.

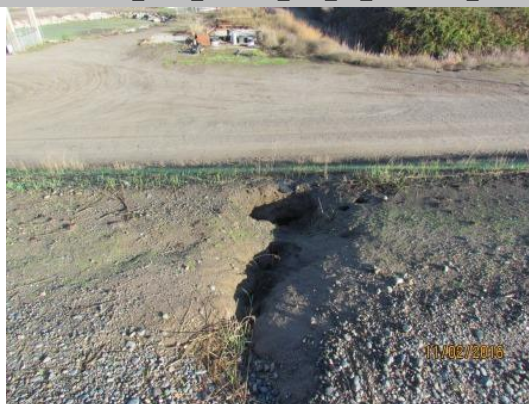
Photo 1 of 2 : SP_2019_ST0009_286_12_20190327_00002.jpg

LM Start	2.16	Rating **	U	Issue No.	12
LM End	2.16	Issue Type +	Ma	Location *	LS
Category	Earthen Levee			GPS Latitude/Longitude	
				Start	End
Item	Animal Control			39.028137 °	39.028137 °
				-121.782020 °	-121.782020 °
DWR ID	DWR_ST0009_01_f_2016_12				
Comment Code					
A3 : No rodents visible, but rodent burrows visible; need to backfill and compact or grout burrows.					
Inspector Comment

View of a rodent hole along the levee crown.

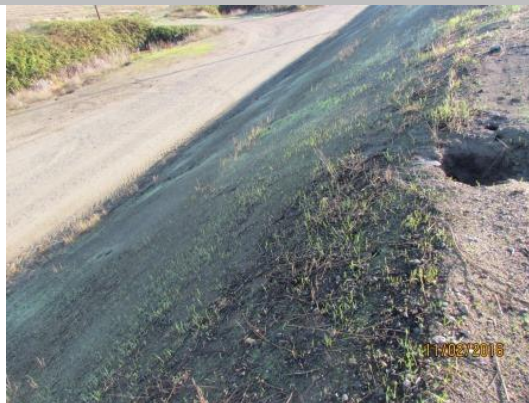
Photo 2 of 2 : SP_2019_ST0009_286_12_20190327_00003.jpg

LM Start	2.16	Rating **	U	Issue No.	12 (cont)	
LM End	2.16	Issue Type +	Ma	Location *	LS	
Category	Earthen Levee			GPS Latitude/Longitude		
				Start		End
Item	Animal Control			39.028137 °		39.028137 °
				-121.782020 °		-121.782020 °
DWR ID	DWR_ST0009_01_f_2016_12					
Comment Code						
A3 : No rodents visible, but rodent burrows visible; need to backfill and compact or grout burrows.						
Inspector Comment

Another view of the rodent holes along the crown and landside slope.

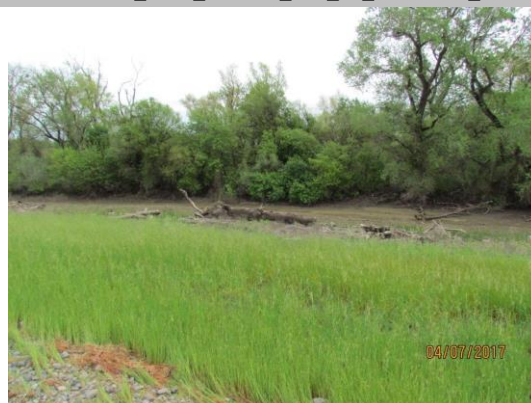
Photo 1 of 1 : SP_2019_ST0009_286_24_20190327_00004.jpg

LM Start	4.35	Rating **	M	Issue No.	24
LM End	4.35	Issue Type +	Ma	Location *	WS
Category	Earthen Levee		GPS Latitude/Longitude		
			Start	End	
Item	Encroachments		39.030637 °	39.030637 °	
			-121.743023 °	-121.743023 °	
DWR ID	DWR_ST0009_01_s _ 2017_24				
Comment Code					
DE : Debris					
Inspector Comment					
Remove the debris from the waterside slope and toe.

View of the debris along the waterside slope and toe.

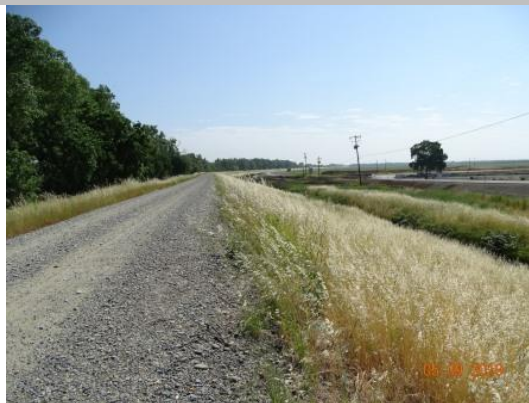
Photo 1 of 1 : SP_2019_ST0009_287_15_20190510_00018.jpg

LM Start	0.00	Rating **	U	Issue No.	15
LM End	4.41	Issue Type +	Ma	Location *	LS
Category	Earthen Levee			GPS Latitude/Longitude	
				Start	End
Item	Vegetation			39.023232 °	39.021637 °
				-121.820730 °	-121.741315 °
DWR ID	DWR_ST0009_02_s_2017_15				
Comment Code					
V1 : Control annual grass and weeds on the levee slopes and easements.					
Inspector Comment

View of the vegetation on the landside slope. Spring 2019.

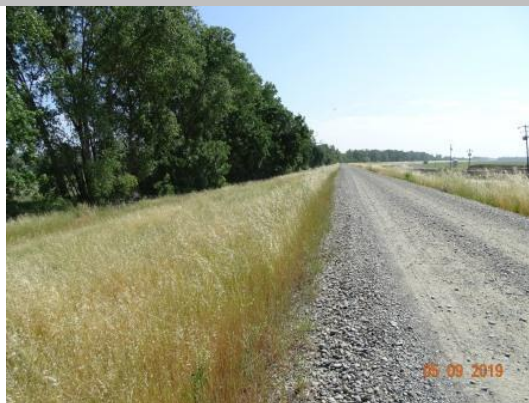
Photo 1 of 1 : SP_2019_ST0009_287_16_20190510_00017.jpg

LM Start	0.00	Rating **	U	Issue No.	16
LM End	4.41	Issue Type +	Ma	Location *	WS
Category	Earthen Levee			GPS Latitude/Longitude	
				Start	End
Item	Vegetation			39.023232 °	39.021637 °
				-121.820730 °	-121.741315 °
DWR ID	DWR_ST0009_02_s_2017_16				
Comment Code					
V1 : Control annual grass and weeds on the levee slopes and easements.					
Inspector Comment

View of the vegetation on the waterside slope. Spring 2019.

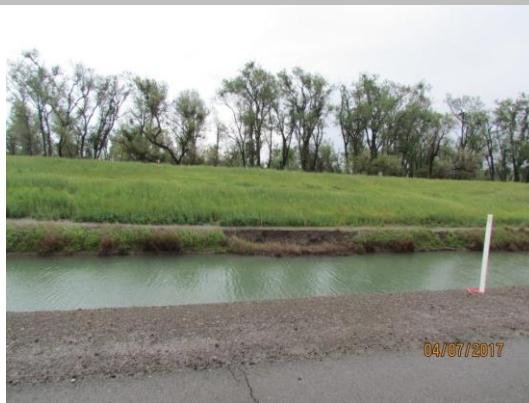
Photo 1 of 1 : SP_2019_ST0009_287_9_20190327_00005.jpg

LM Start	0.69	Rating **	M	Issue No.	9
LM End	0.71	Issue Type +	Ma	Location *	LS
Category	Earthen Levee			GPS Latitude/Longitude	
				Start	End
Item	Erosion / Bank Caving			39.025602 °	39.025657 °
				-121.808527 °	-121.808027 °
DWR ID	DWR_ST0009_02_s_2017_9				
Comment Code					
E2 : Schedule repair of erosion site prior to the next inspection.					
Inspector Comment

View of the erosion along the landside toe from the County Road.

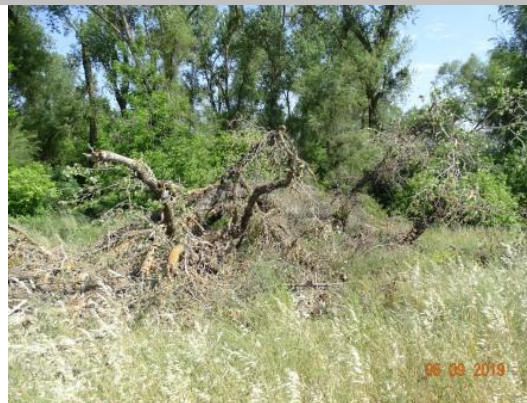
Photo 1 of 1 : SP_2019_ST0009_287_7_20190510_00019.jpg

LM Start	0.92	Rating **	U	Issue No.	7
LM End	0.92	Issue Type +	Ma	Location *	WS
Category	Earthen Levee			GPS Latitude/Longitude	
				Start	End
Item	Encroachments			39.025536 °	39.025536 °
				-121.804139 °	-121.804139 °
DWR ID	DWR_ST0009_02_s_2019_7				
Comment Code					
TR : Tree or limb					
Inspector Comment					
The large tree should be removed from the waterside slope.

View of a large tree on the waterside slope. Spring 2019.

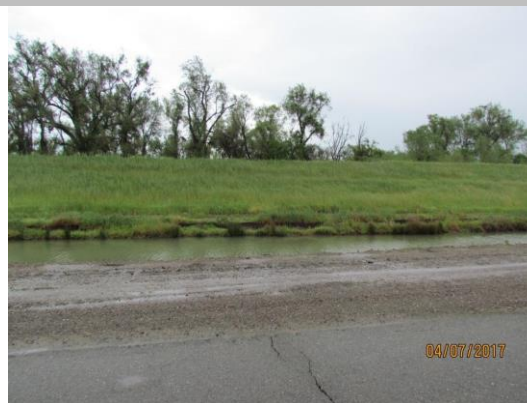
Photo 1 of 1 : SP_2019_ST0009_287_10_20190327_00006.jpg

LM Start	0.97	Rating **	M	Issue No.	10
LM End	0.98	Issue Type +	Ma	Location *	LS
Category	Earthen Levee			GPS Latitude/Longitude	
				Start	End
Item	Erosion / Bank Caving			39.025540 °	39.025572 °
				-121.803272 °	-121.802990 °
DWR ID	DWR_ST0009_02_s_2017_10				
Comment Code					
E2 : Schedule repair of erosion site prior to the next inspection.					
Inspector Comment

View of the erosion along the landside toe from the County Road.

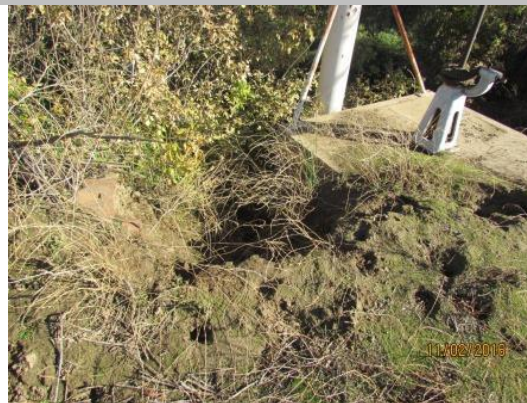
Photo 1 of 2 : SP_2019_ST0009_287_13_20190327_00007.jpg

LM Start	1.14	Rating **	M	Issue No.	13
LM End	1.14	Issue Type +	Ma	Location *	WS
Category	Earthen Levee			GPS Latitude/Longitude	
				Start	End
Item	Erosion / Bank Caving			39.025460 °	39.025460 °
				-121.800022 °	-121.800022 °
DWR ID	DWR_ST0009_02_f_2016_13				
Comment Code					
E2 : Schedule repair of erosion site prior to the next inspection.					
Inspector Comment					
Erosion around the WS concrete vault.

View of the erosion along the concrete vault.

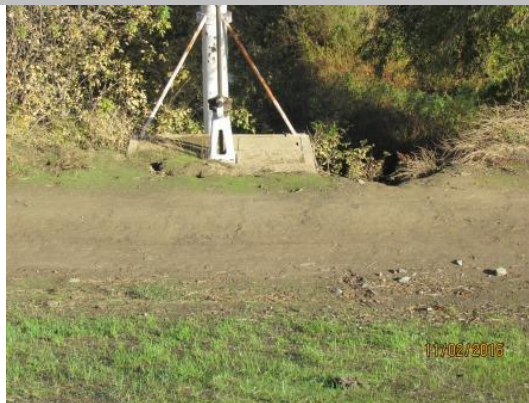
Photo 2 of 2 : SP_2019_ST0009_287_13_20190327_00008.jpg

LM Start	1.14	Rating **	M	Issue No.	13 (cont)	
LM End	1.14	Issue Type +	Ma	Location *	WS	
Category	Earthen Levee			GPS Latitude/Longitude		
				Start		End
Item	Erosion / Bank Caving			39.025460 °		39.025460 °
				-121.800022 °		-121.800022 °
DWR ID	DWR_ST0009_02_f_2016_13					
Comment Code						
E2 : Schedule repair of erosion site prior to the next inspection.						
Inspector Comment						
Erosion around the WS concrete vault.

Another view of the erosion along the concrete vault.

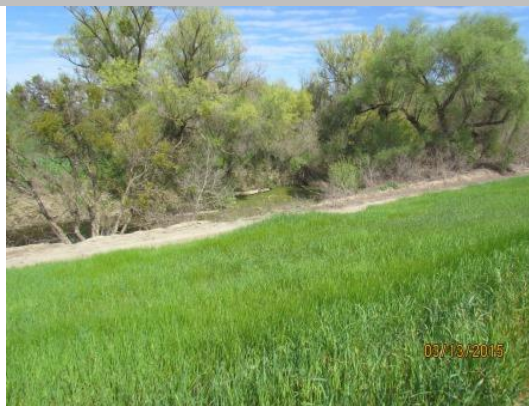
Photo 1 of 1 : SP_2019_ST0009_287_290_20190327_00010.jpg

LM Start	1.19	Rating **	A/W	Issue No.	290
LM End	1.19	Issue Type +	Ma	Location *	WS
Category	Earthen Levee			GPS Latitude/Longitude	
				Start	End
Item	Erosion / Bank Caving			39.025490 °	39.025490 °
				-121.799240 °	-121.799240 °
DWR ID	DWR_ST0009_02_s_2015_290				
Comment Code					
E1 : Note and monitor erosion site.					
Inspector Comment					
Sutter Yard needs to monitor the erosion along the berm.

View of the erosion along the waterside berm.

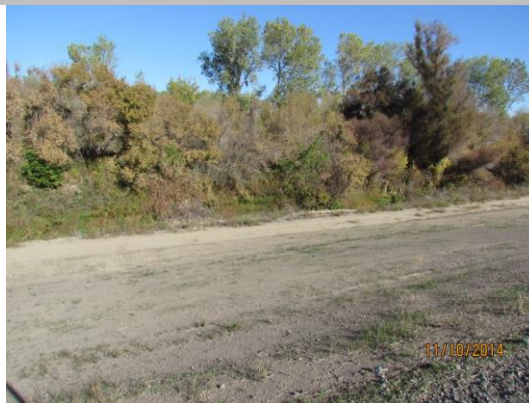
Photo 1 of 1 : SP_2019_ST0009_287_4_20190327_00003.jpg

LM Start	1.29	Rating **	A/W	Issue No.	4
LM End	1.29	Issue Type +	Ma	Location *	WS
Category	Earthen Levee			GPS Latitude/Longitude	
				Start	End
Item	Erosion / Bank Caving			39.025478 °	39.025478 °
				-121.797232 °	-121.797232 °
DWR ID	DWR_ST0009_02_s_2013_4				
Comment Code					
E2 : Schedule repair of erosion site prior to the next inspection.					
Inspector Comment					
Sutter Yard needs to monitor the erosion.

View of the erosion along the waterside berm.

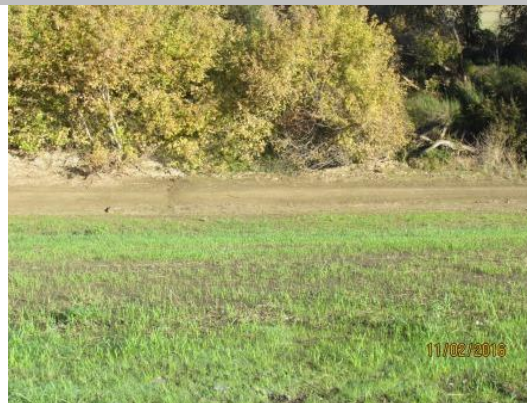
Photo 1 of 1 : SP_2019_ST0009_287_5_20190327_00004.jpg

LM Start	1.48	Rating **	A/W	Issue No.	5
LM End	1.50	Issue Type +	Ma	Location *	WS
Category	Earthen Levee			GPS Latitude/Longitude	
				Start	End
Item	Erosion / Bank Caving			39.025460 °	39.025446 °
				-121.793815 °	-121.793347 °
DWR ID	DWR_ST0009_02_s_2013_5				
Comment Code					
E2 : Schedule repair of erosion site prior to the next inspection.					
Inspector Comment					
Sutter Yard needs to monitor the erosion.

View of the erosion along the waterside berm.

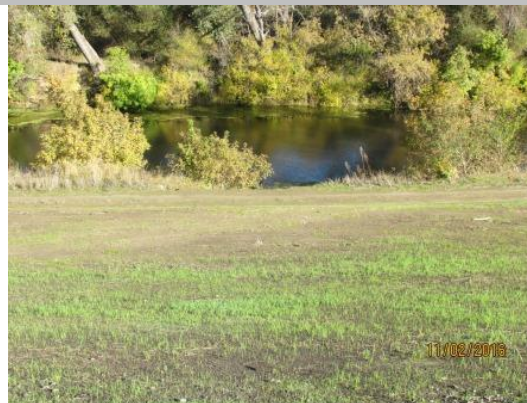
Photo 1 of 1 : SP_2019_ST0009_287_2_20190327_00002.jpg

LM Start	3.93	Rating **	A/W	Issue No.	2
LM End	3.93	Issue Type +	Ma	Location *	WS
Category	Earthen Levee			GPS Latitude/Longitude	
				Start	End
Item	Erosion / Bank Caving			39.025060 °	39.025060 °
				-121.748178 °	-121.748178 °
DWR ID	DWR_ST0009_02_f_2016_2				
Comment Code					
E1 : Note and monitor erosion site.					
Inspector Comment

View of the erosion along the waterside berm.

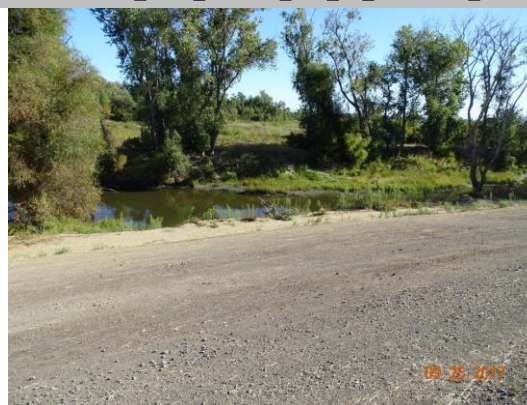
Photo 1 of 1 : SP_2019_ST0009_287_18_20190327_00009.jpg

LM Start	4.09	Rating **	A/W	Issue No.	18
LM End	4.09	Issue Type +	Ma	Location *	WS
Category	Earthen Levee			GPS Latitude/Longitude	
				Start	End
Item	Erosion / Bank Caving			39.024912 °	39.024912 °
				-121.745237 °	-121.745237 °
DWR ID	DWR_ST0009_02_f_2017_18				
Comment Code					
E1 : Note and monitor erosion site.					
Inspector Comment

View of the erosion along the waterside berm.

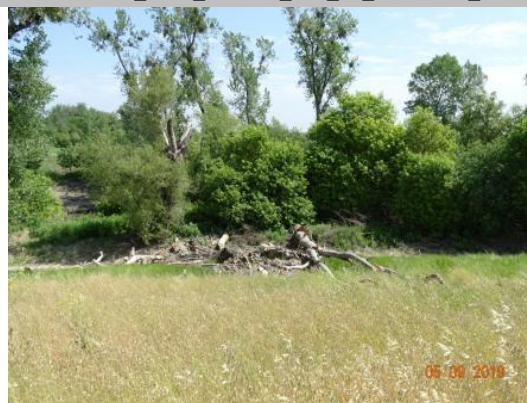
Photo 1 of 1 : SP_2019_ST0009_287_12_20190510_00020.jpg

LM Start	4.17	Rating **	M	Issue No.	12
LM End	4.17	Issue Type +	Ma	Location *	WS
Category	Earthen Levee			GPS Latitude/Longitude	
				Start	End
Item	Encroachments			39.024408 °	39.024408 °
				-121.743920 °	-121.743920 °
DWR ID	DWR_ST0009_02_s_2019_12				
Comment Code					
TR : Tree or limb					
Inspector Comment					
The large tree should be removed from the waterside slope and toe.

View of a large tree on the waterside slope and toe. Spring 2019.
